LAKE LEHMAN DAM

(NDI ^{Number} NO. PA-00341
DER ^{Number} NO. 67-480), Susquehanna River Basin,

PHASE I INSPECTION REPORT,
NATIONAL DAM INSPECTION PROGRAM

11 FEBRUARY 1981

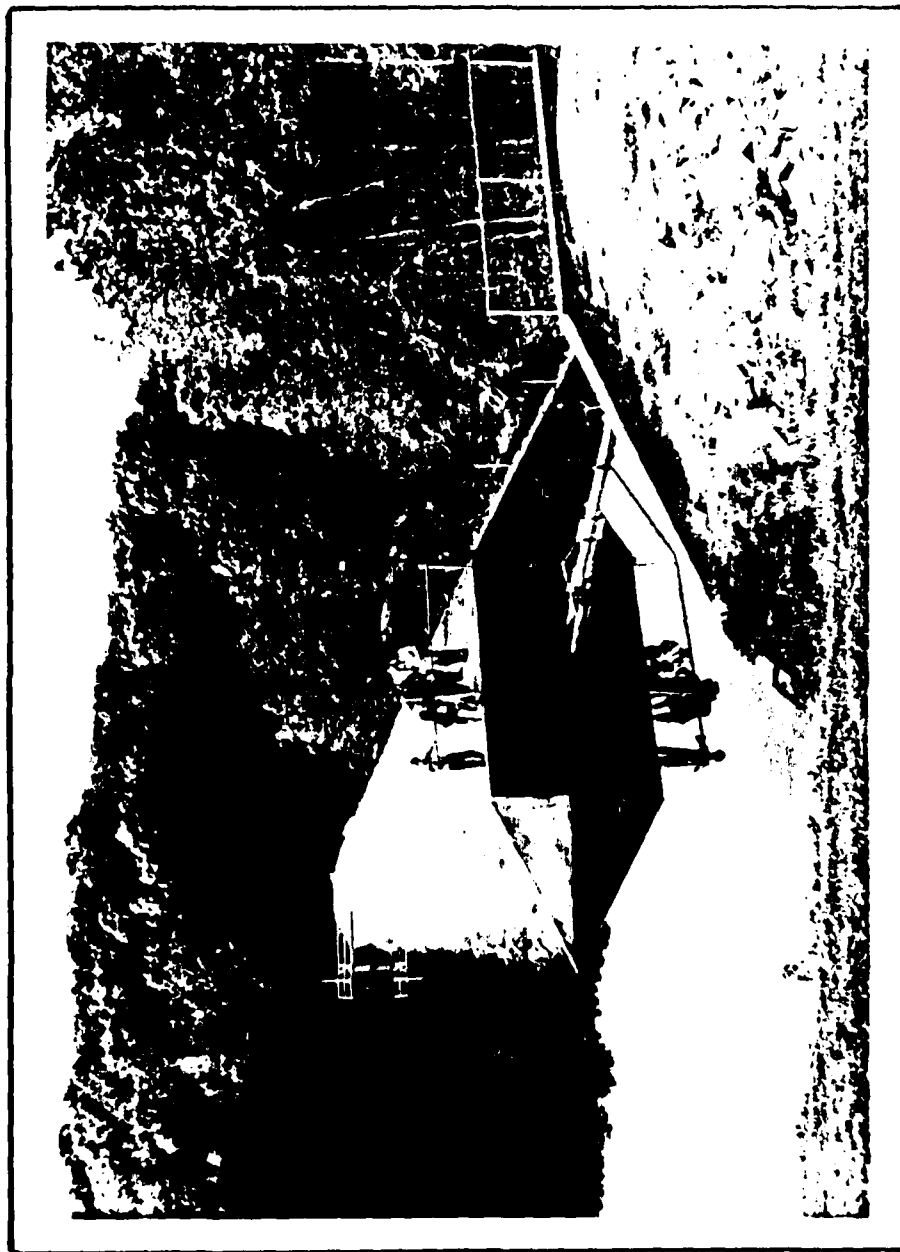
Photograph No. 1

OVERVIEW

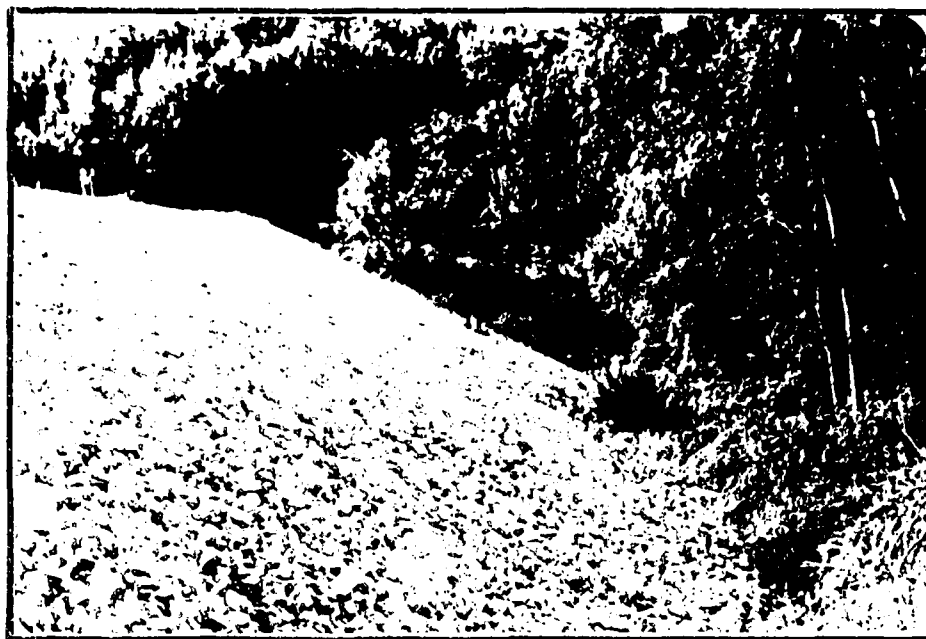
GENERAL VIEW OF DOWNSTREAM SLOPE - NO. 2

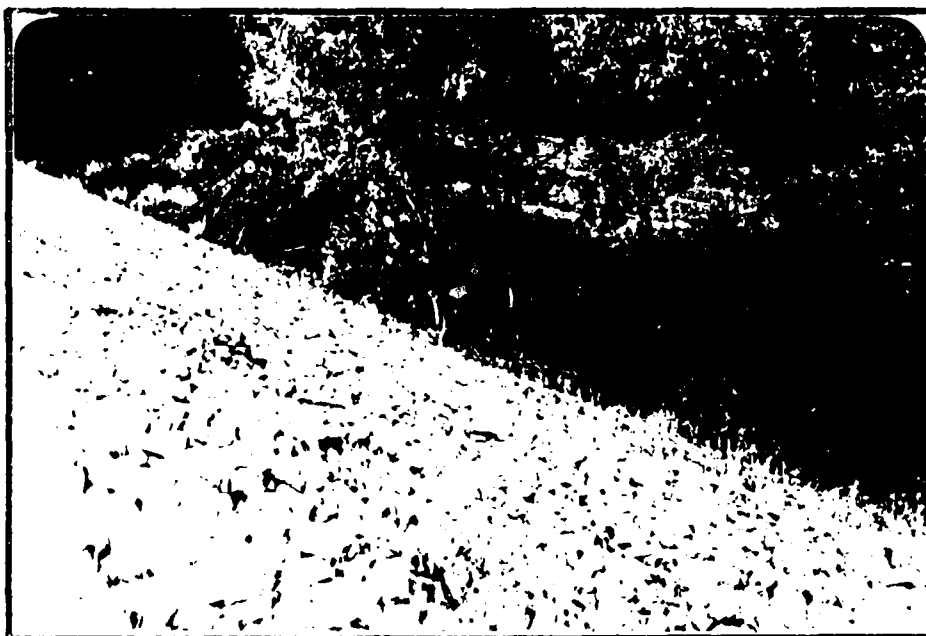
The general appearance of Lake Lehman Dam is good. The slopes are protected with dumped rock and clear of brush and weeds except at the downstream toe. The toe is overgrown with heavy brush and brambles. Water was detected running in the rock toe at the left side; however, brush prevented close observation of this condition. A wet flat area is located immediately to the left of the outlet pipe. Water is flowing into the outlet channel from this seepage.

VIEW OF BRUSH AT DOWNSTREAM TOE - NO. 3

2. That the downstream toe and an area 20 feet beyond the toe be cleared on a regular basis of all brush, weeds and trees, permitting close observation of the seepage.
3. That the slab joints in the spillway channel be filled with a joint material.
4. That the seepage be monitored on a regular basis. If turbidity or an increase in flow is detected, immediate action shall be taken to correct this condition.
5. That close observation be maintained of the tilted walls in the spillway. If additional movement is recorded, measures shall be taken to correct this condition.
6. That an operation and maintenance manual be prepared for guidance in the operation of the dam during normal and emergency conditions, and that a schedule be developed for the annual inspection of the dam and its appurtenant structures.

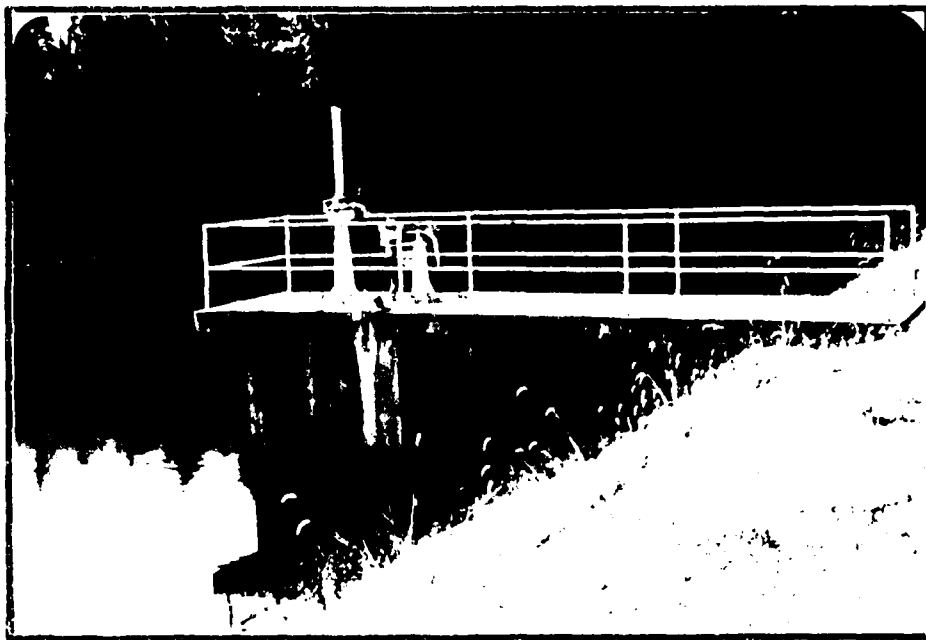
UPSTREAM CONTROL TOWER WITH FOOTBRIDGE - NO. 4

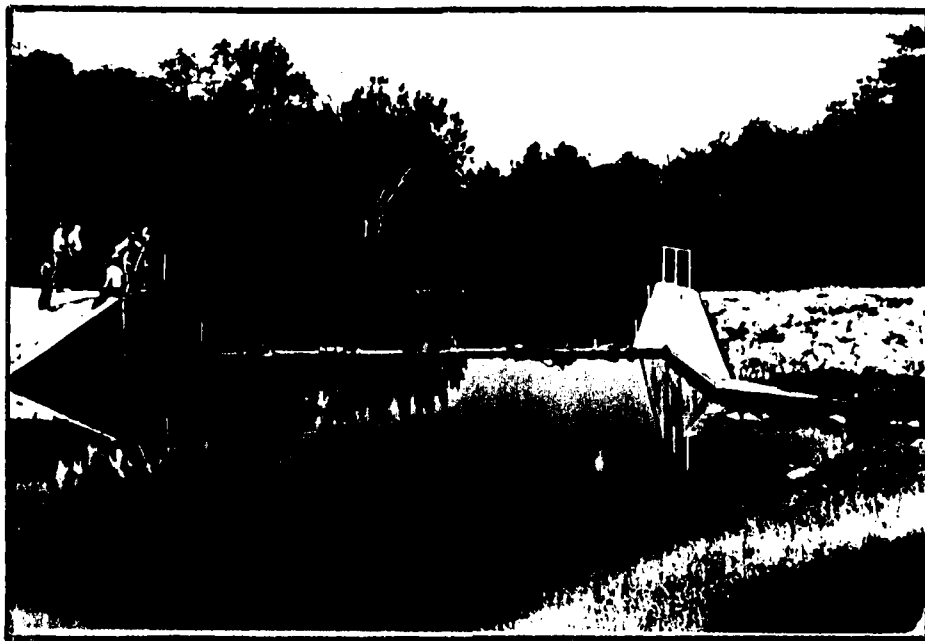
FOREBAY & SPILLWAY ABUTMENT WALLS - NO. 6

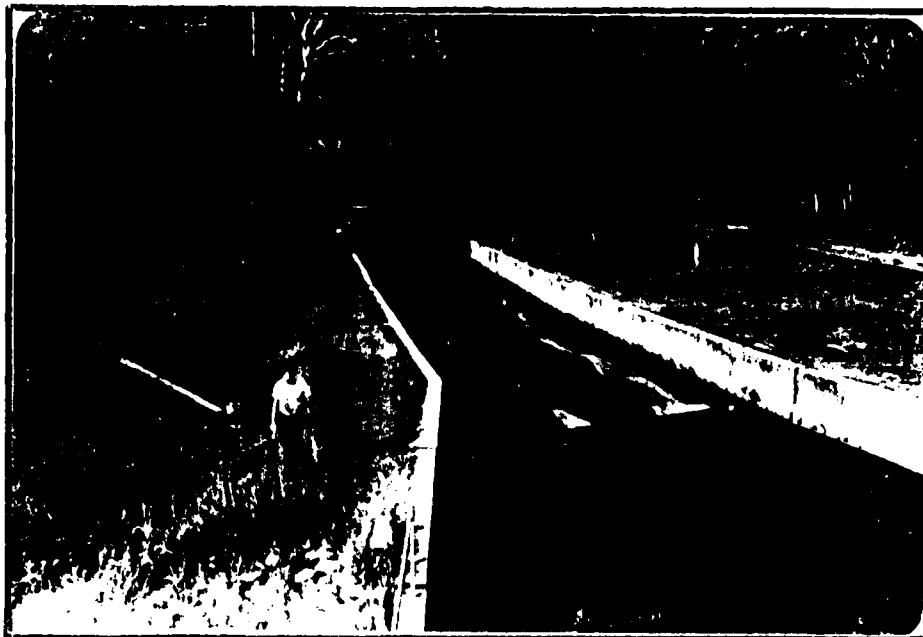
SPILLWAY CHANNEL WITH FOOTBRIDGE -- NO. 8

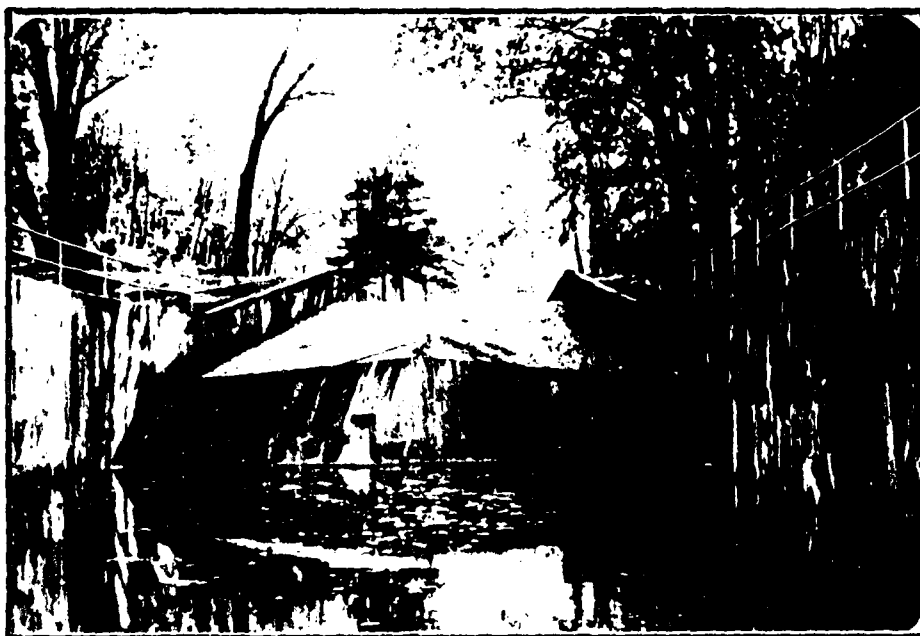
STILLING BASIN LOOKING UPSTREAM - NO. 10

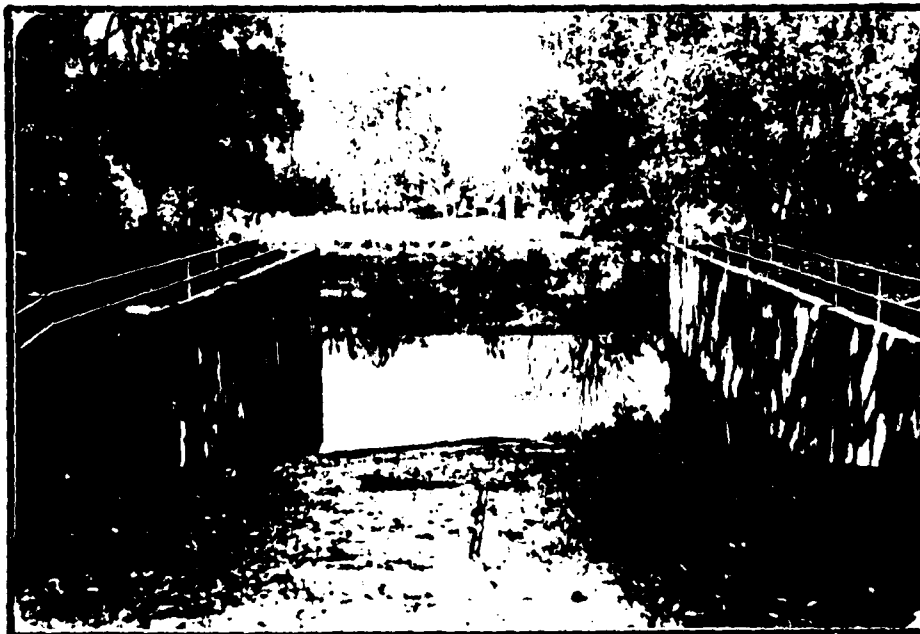
DOWNSTREAM CHANNEL - NO. 11
NOTE: TILTED WALL

5. That close observation be maintained of the tilted walls in the spillway. If additional movement is recorded, measures shall be taken to correct this condition.
6. That an operation and maintenance manual be prepared for guidance in the operation of the dam during normal and emergency conditions, and that a schedule be developed for the annual inspection of the dam and its appurtenant structures.
